FIELD PERFORMANCE OF ENERGY-EFFICIENT RESIDENTIAL BUILDING ENVELOPE SYSTEMS

Efficiency and Alternative Energy Technology Branch
Energy, Mines and Resources Canada
Ottawa, Ont.
May, 1992

UNIES Ltd.
1666 Dublin Ave.
Winnipeg, Man. R3H 0H1

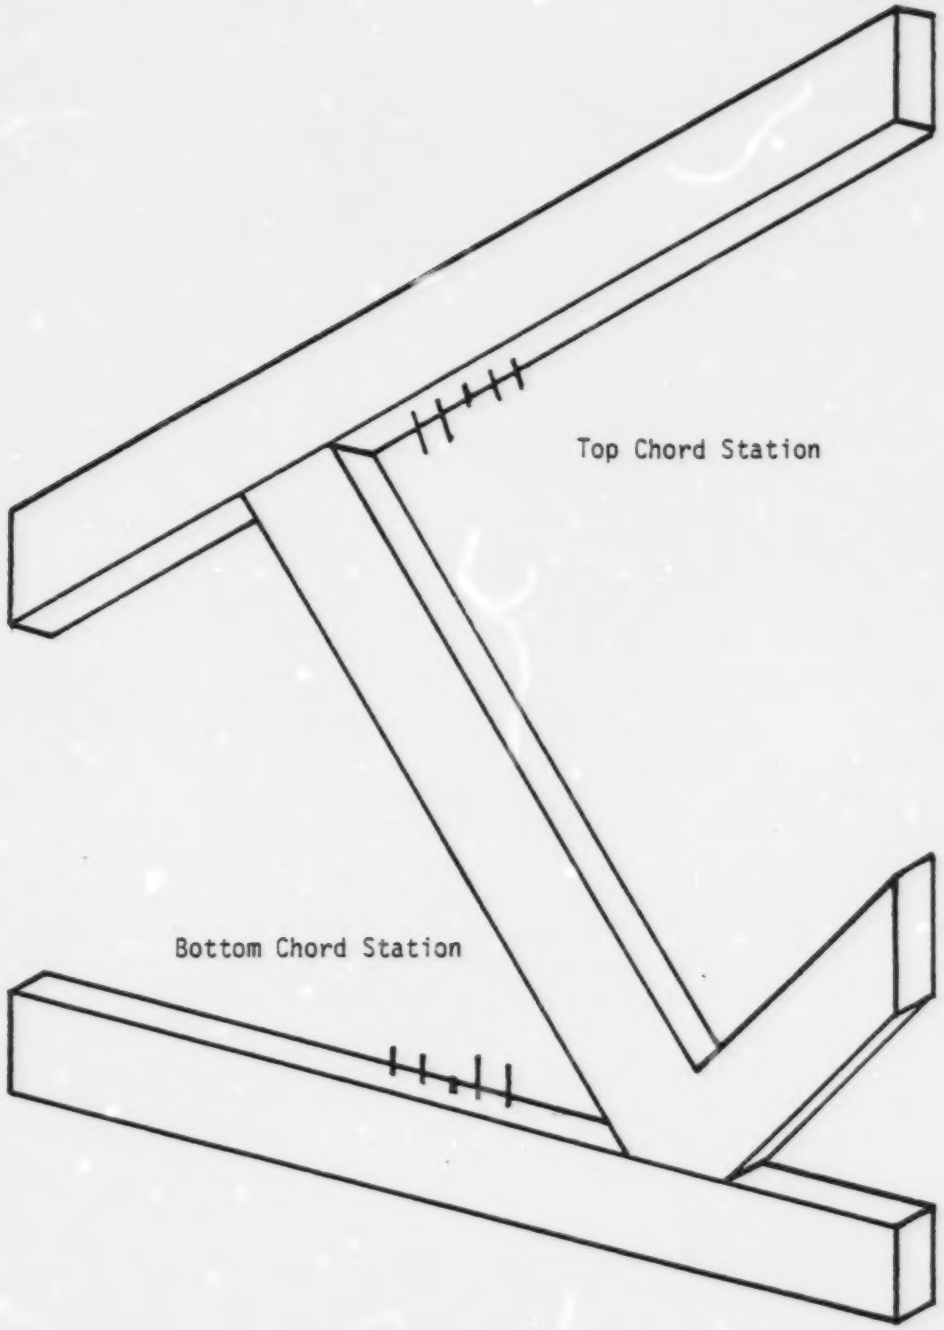
TYPICAL ATTIC TRUSS WMC INSTRUMENTATION
FIGURE 2

Wood moisture monitoring stations were installed on the top and bottom chords of the roof trusses in several houses. A typical installation is shown in Fig. 2.

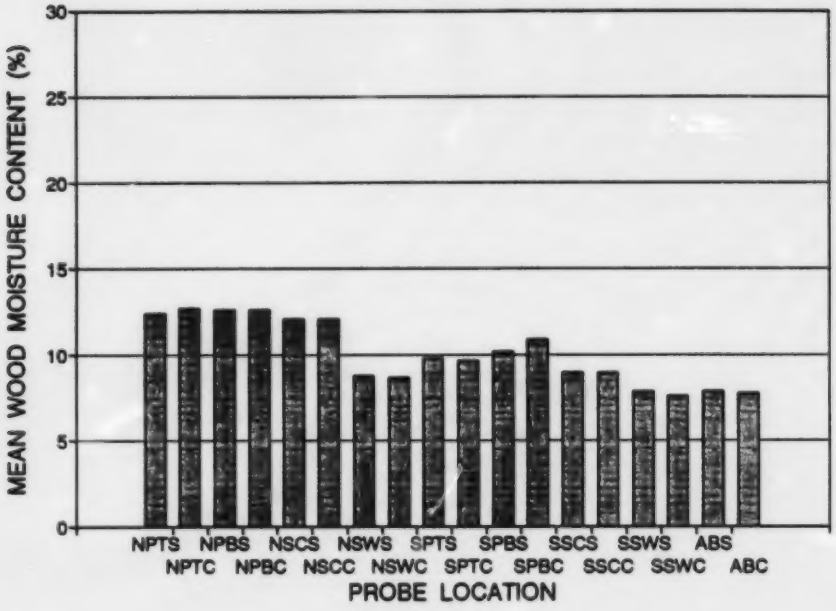
FIGURE 4

HOUSE #1

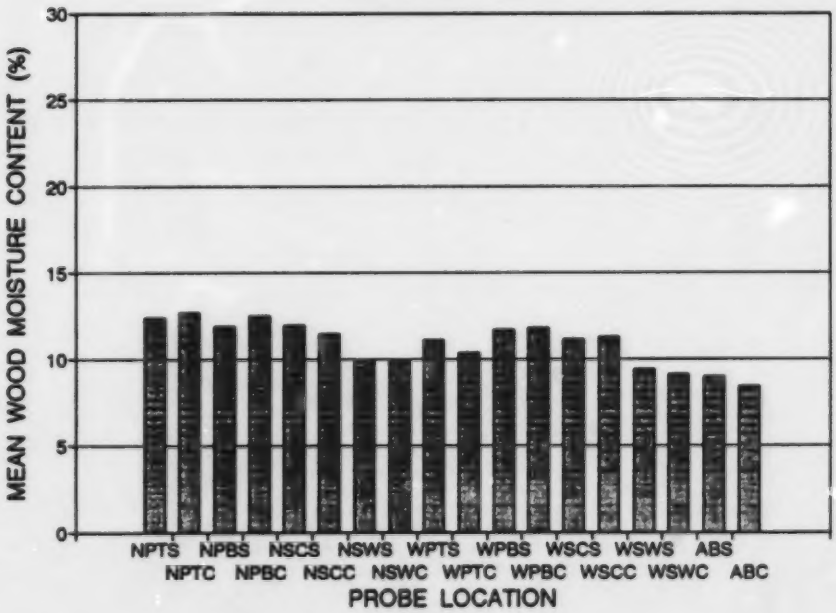
FIGURE 5

HOUSE #2

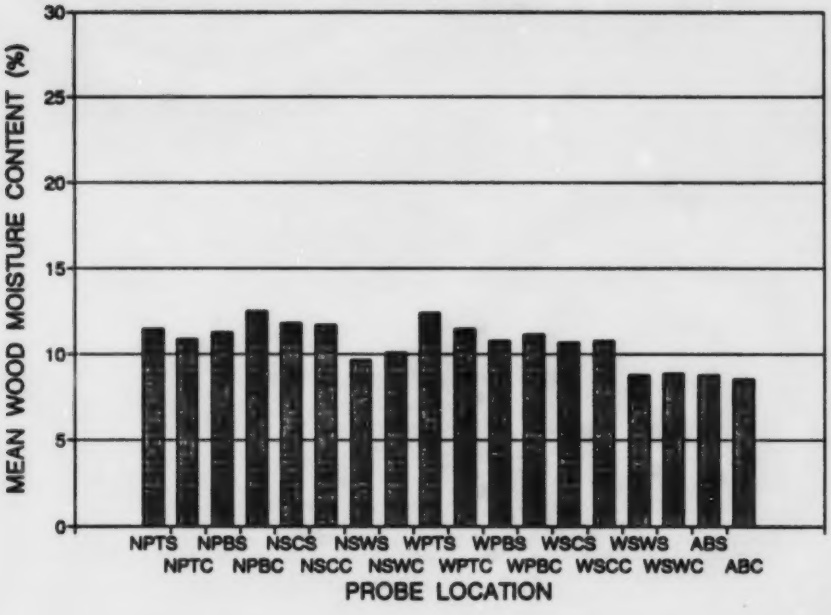
FIGURE 6

HOUSE #3

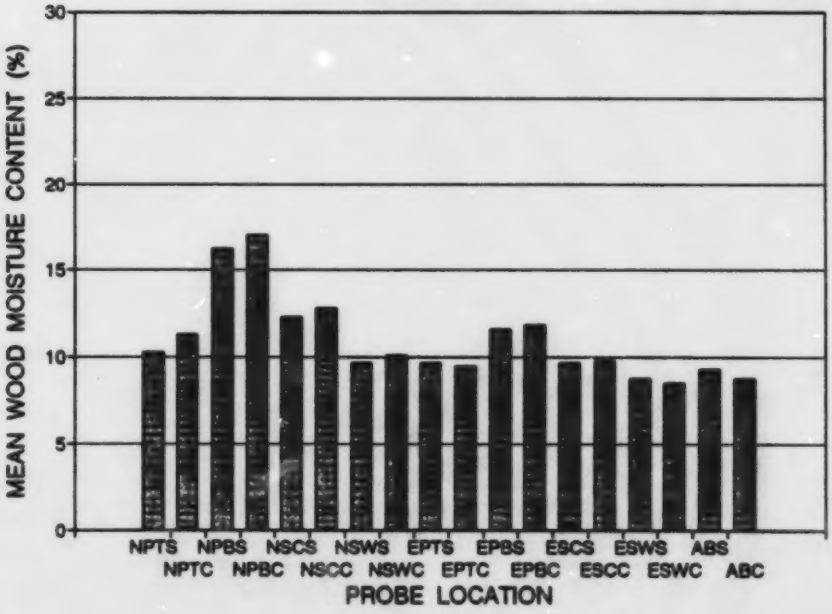
FIGURE 7

HOUSE #4

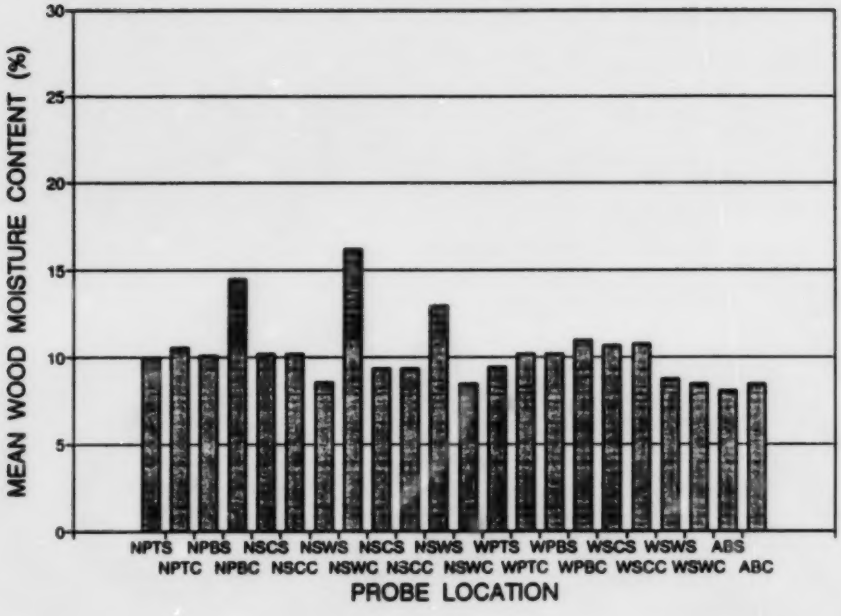
FIGURE 8

HOUSE #5

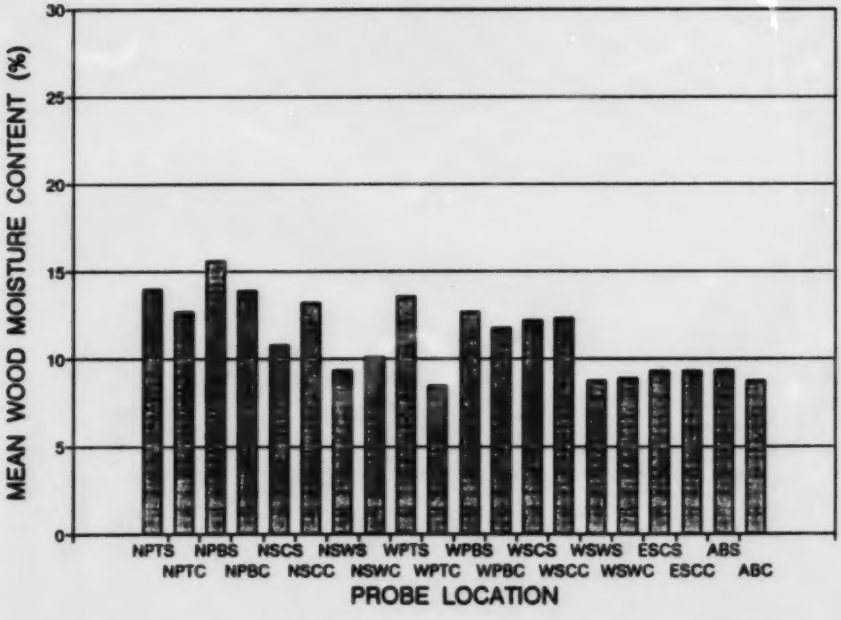
FIGURE 9

HOUSE #6

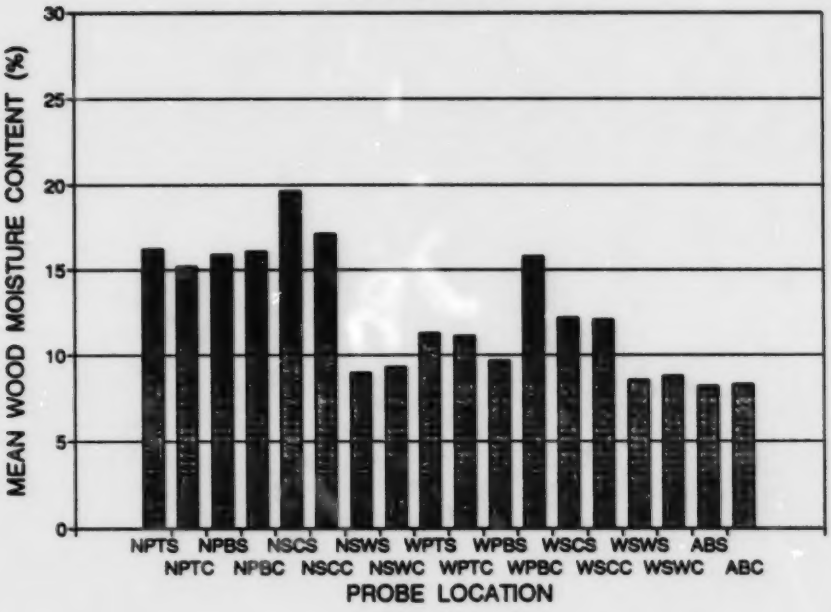
FIGURE 10

HOUSE #7

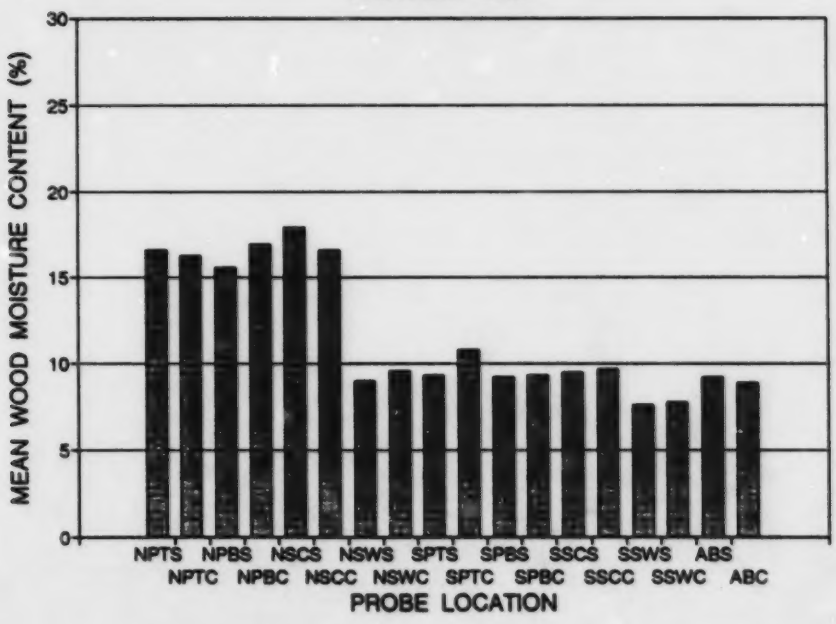
FIGURE 11

HOUSE #8

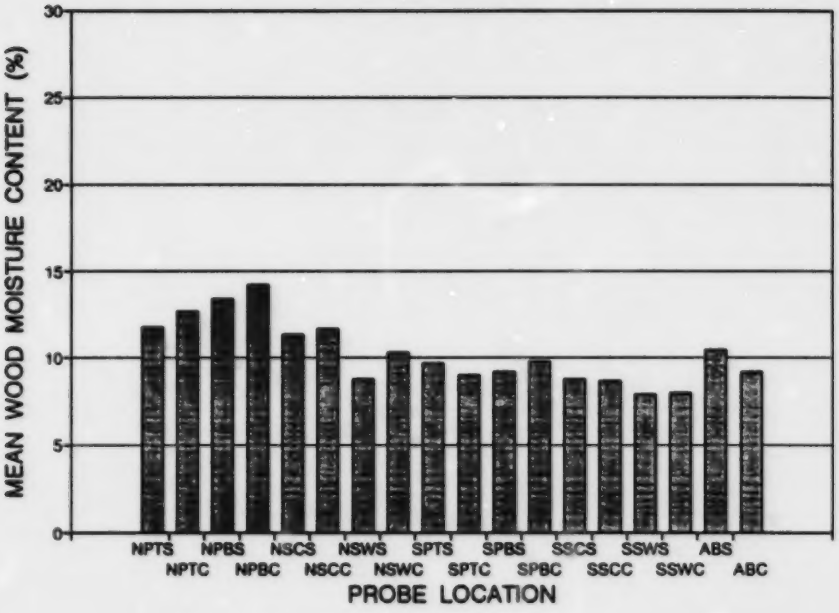
FIGURE 12

HOUSE #9

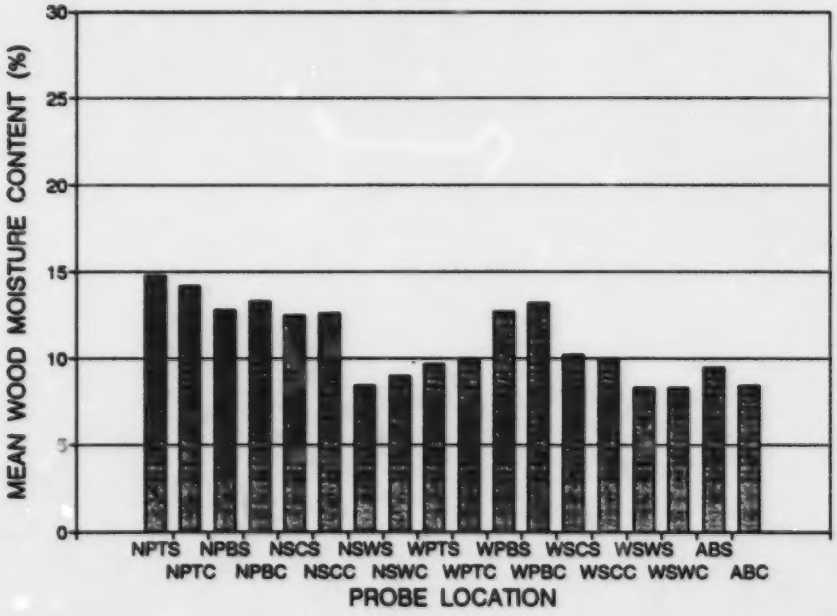
FIGURE 13

HOUSE #10

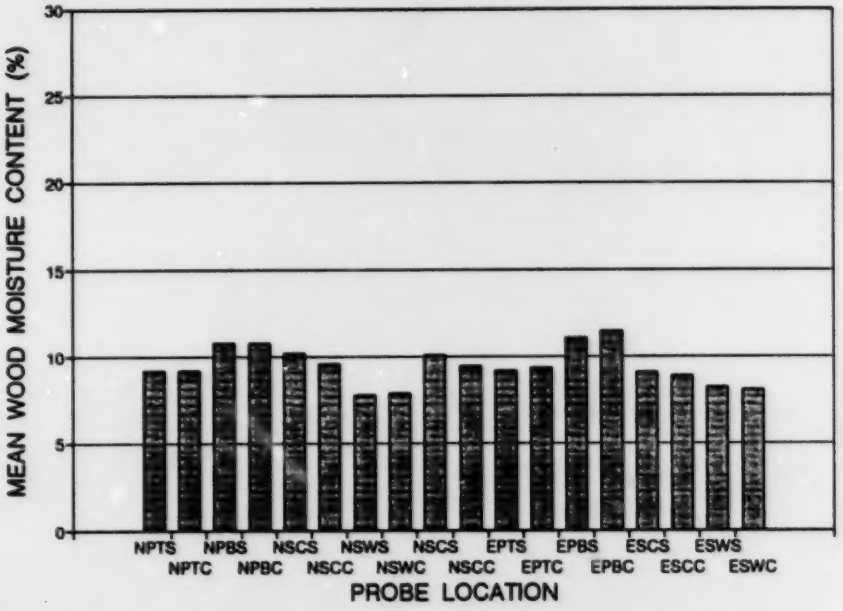
FIGURE 15(a)

HOUSE #12

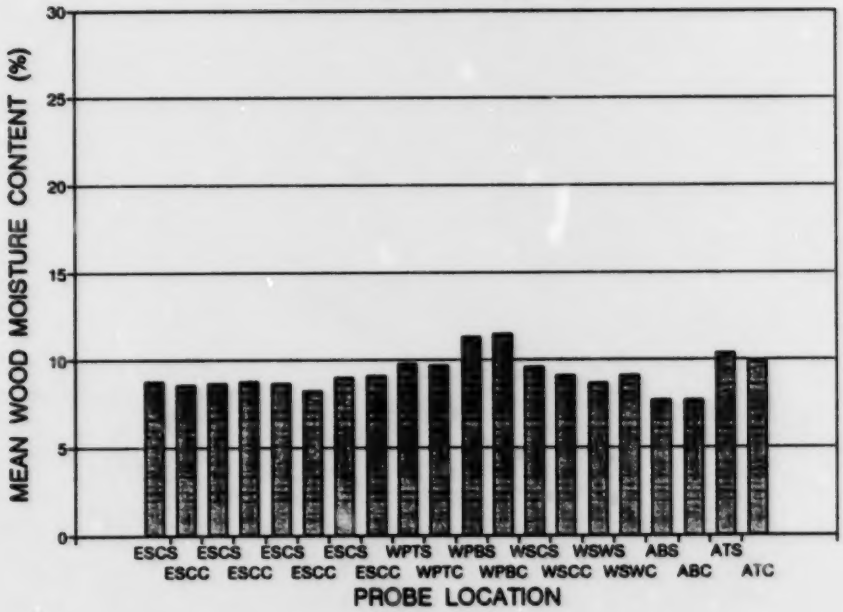
FIGURE 15(b)

HOUSE #12 (con't)

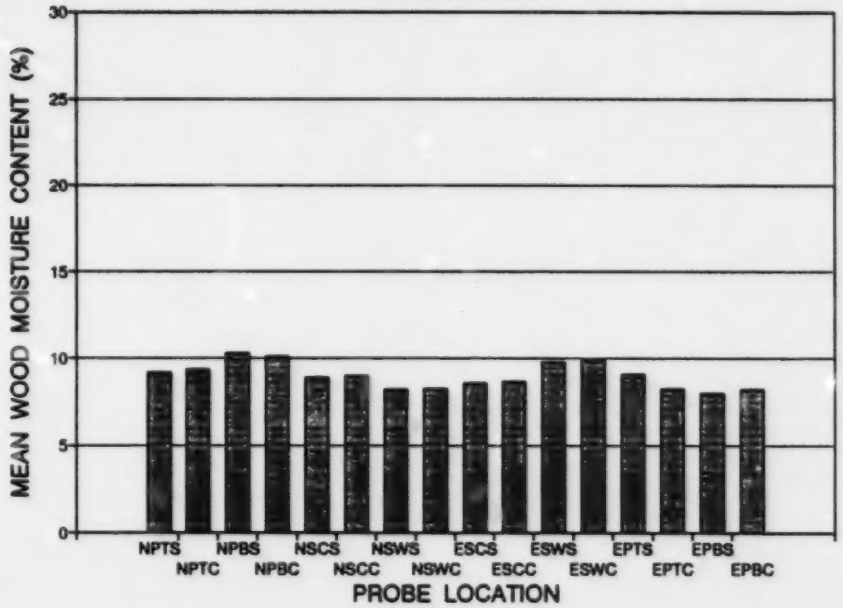
FIGURE 16(a)

HOUSE #15

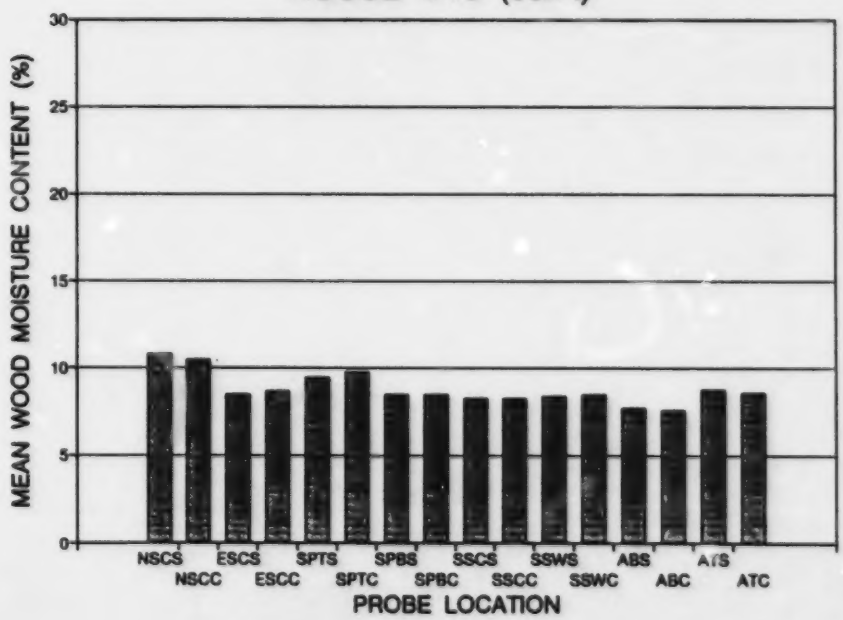
FIGURE 16(b)

HOUSE #15 (con't)

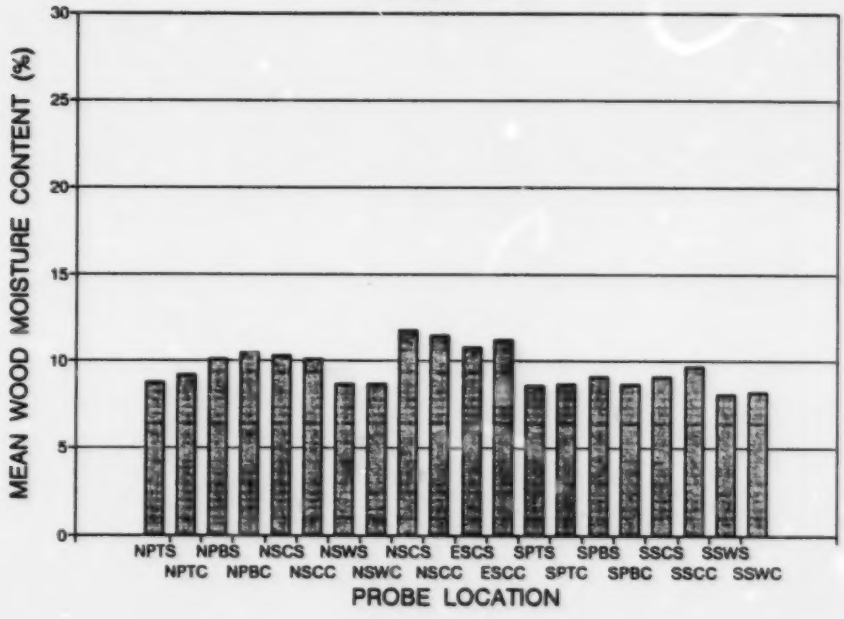
FIGURE 17(a)

HOUSE #16

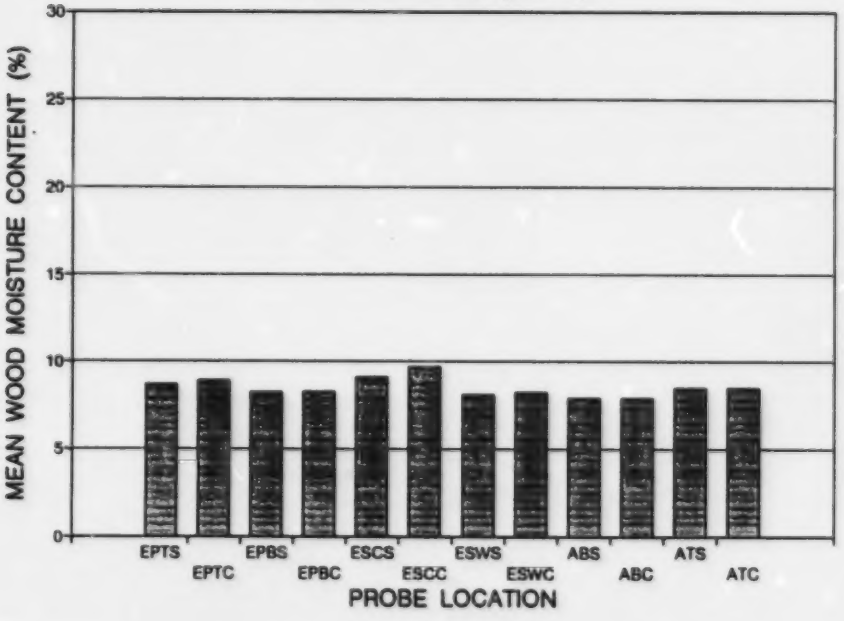
FIGURE 17(b)

HOUSE #16 (con't)

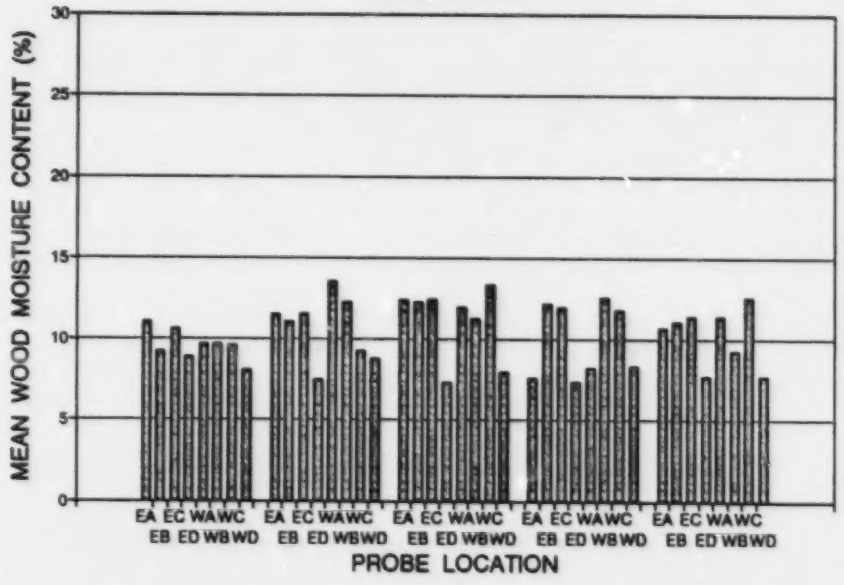
FIGURE 18

HOUSE #18
(FLOOR JOISTS)

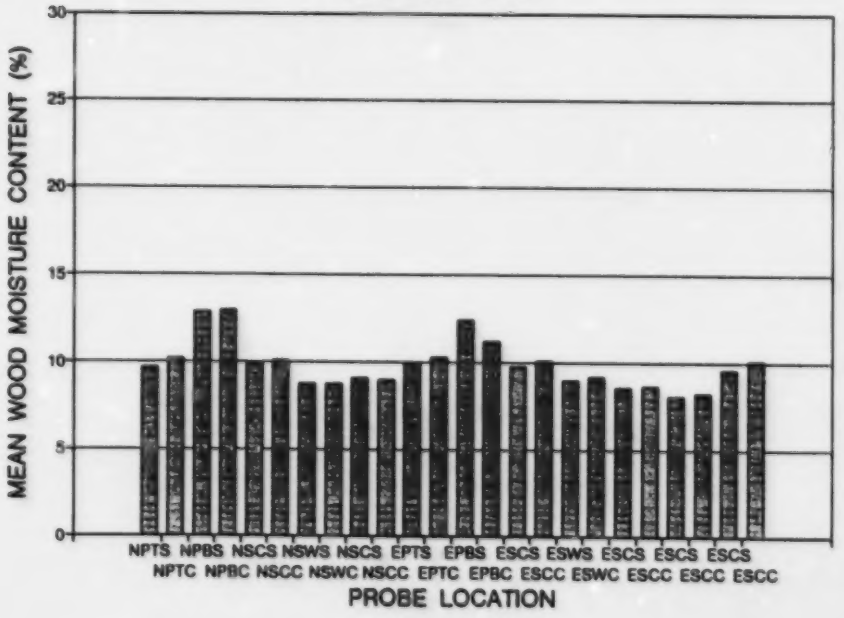
FIGURE 19(a)

HOUSE #19

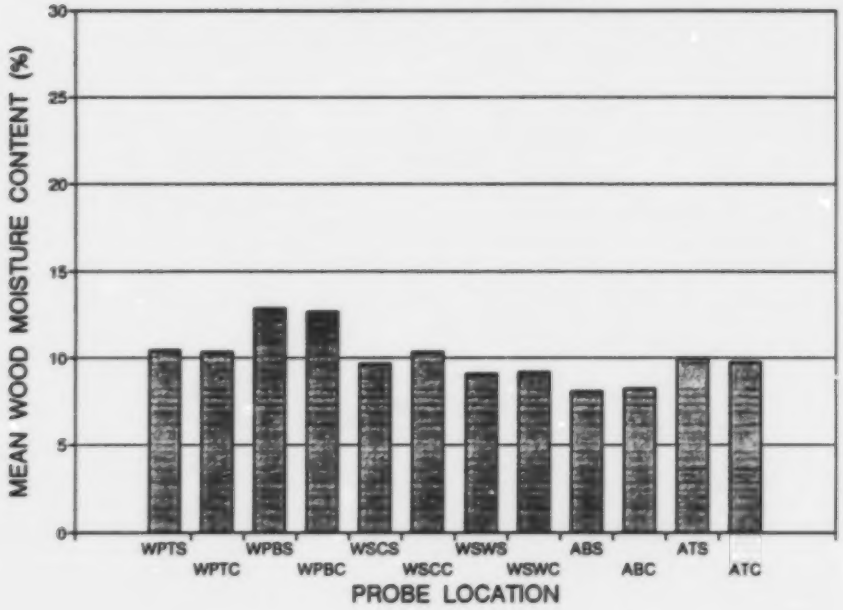
FIGURE 19(b)

HOUSE #19 (con't)

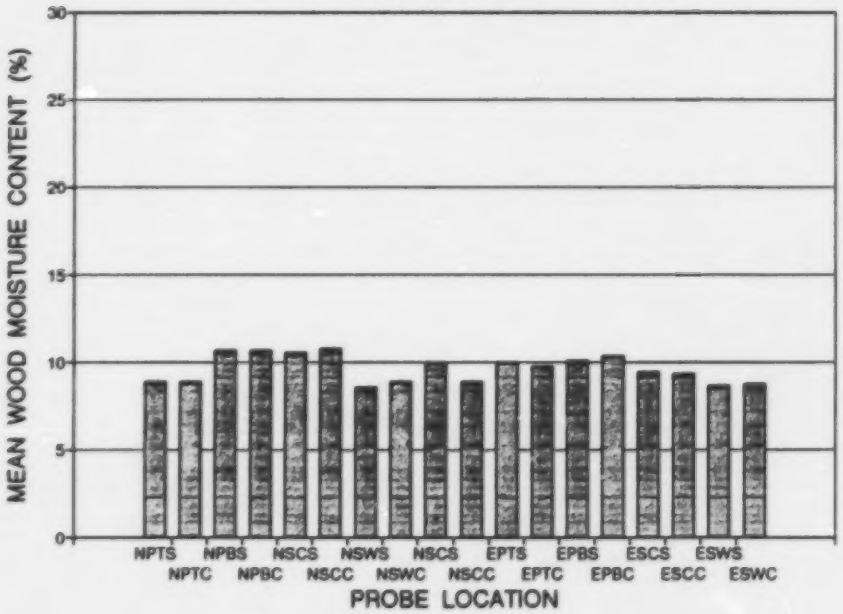
FIGURE 20(a)

HOUSE #20

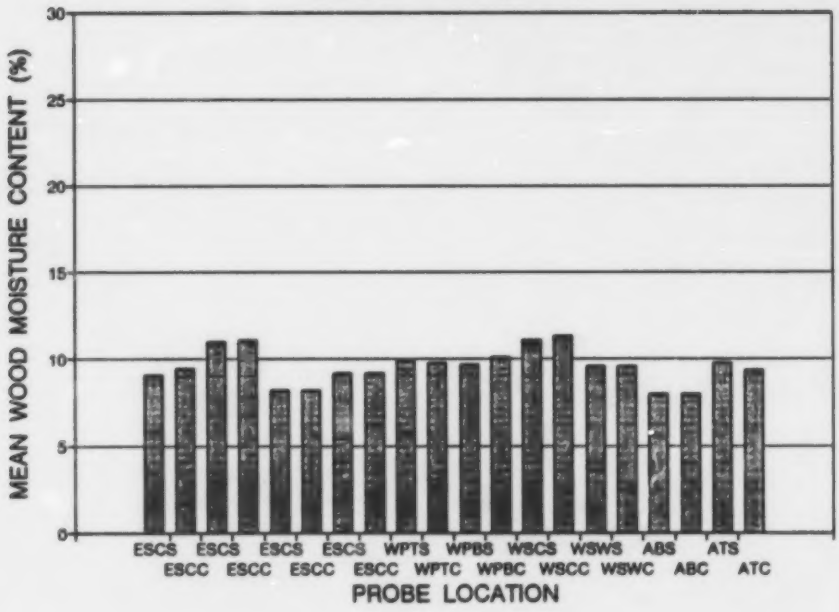
FIGURE 20(b)

HOUSE #20 (con't)

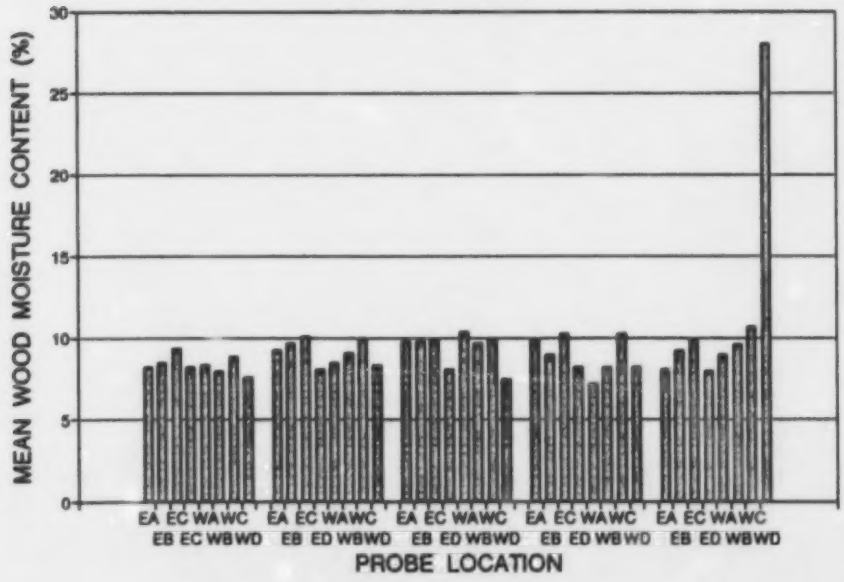
FIGURE 20(c)

HOUSE #20 (con't)
(FLOOR JOISTS)

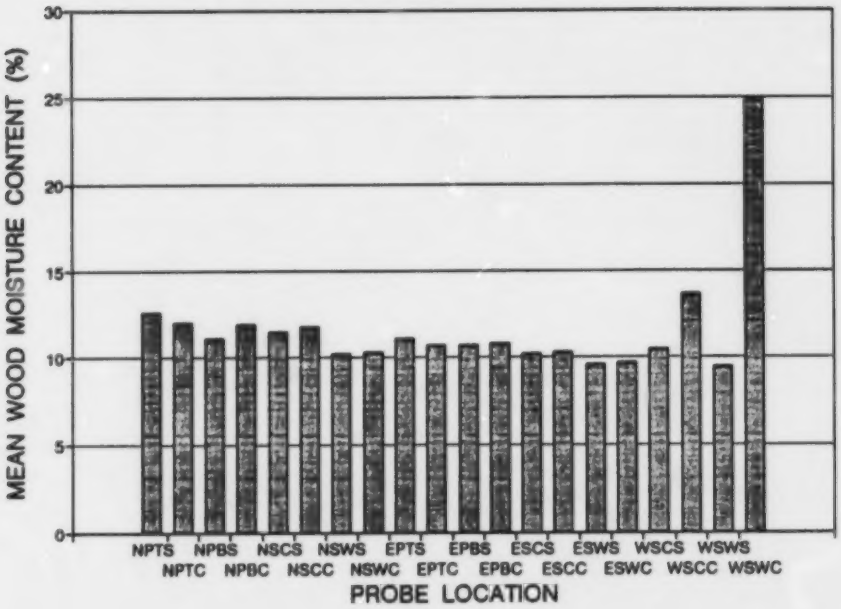
FIGURE 21(a)

HOUSE #23

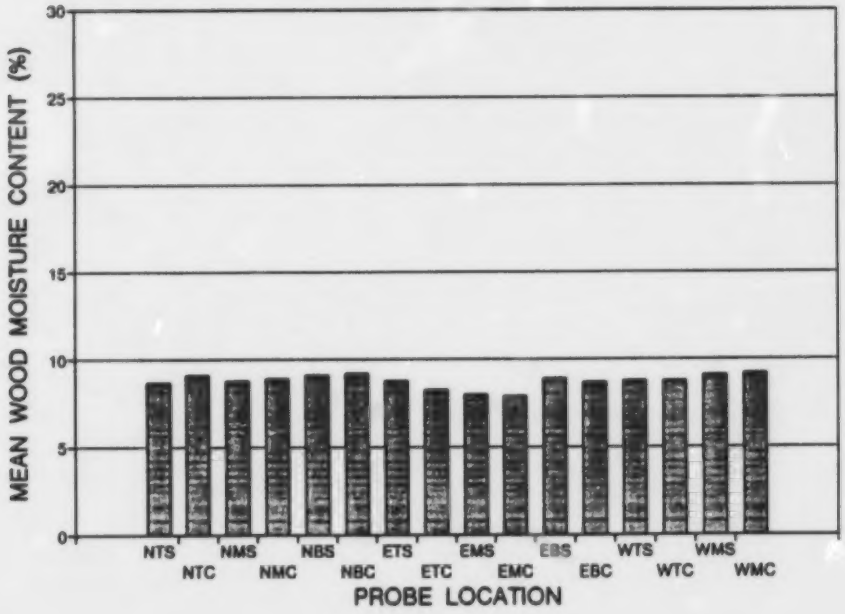
FIGURE 21(b)

HOUSE #23 (con't)

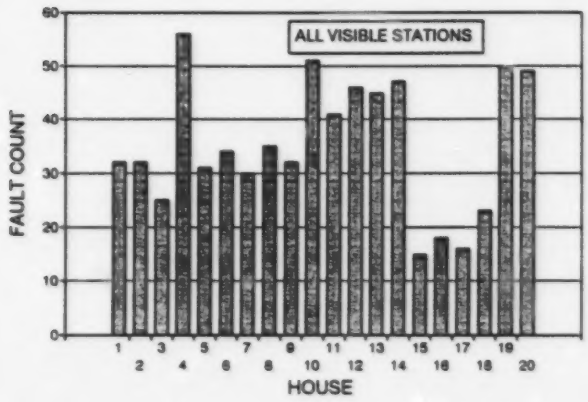
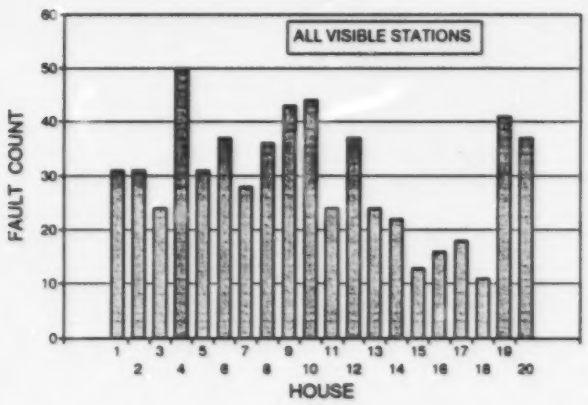
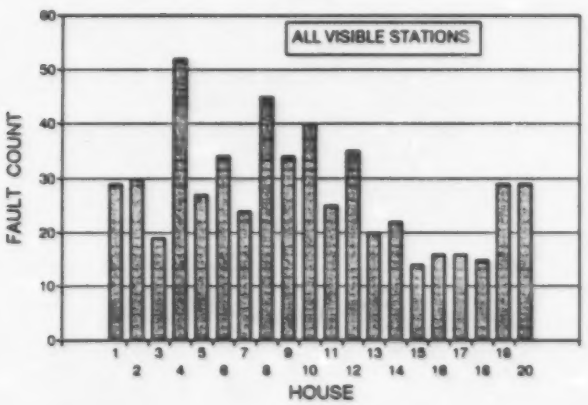
FIGURES 24, 25 and 26

These results are also shown in Figs. 24 to 35.

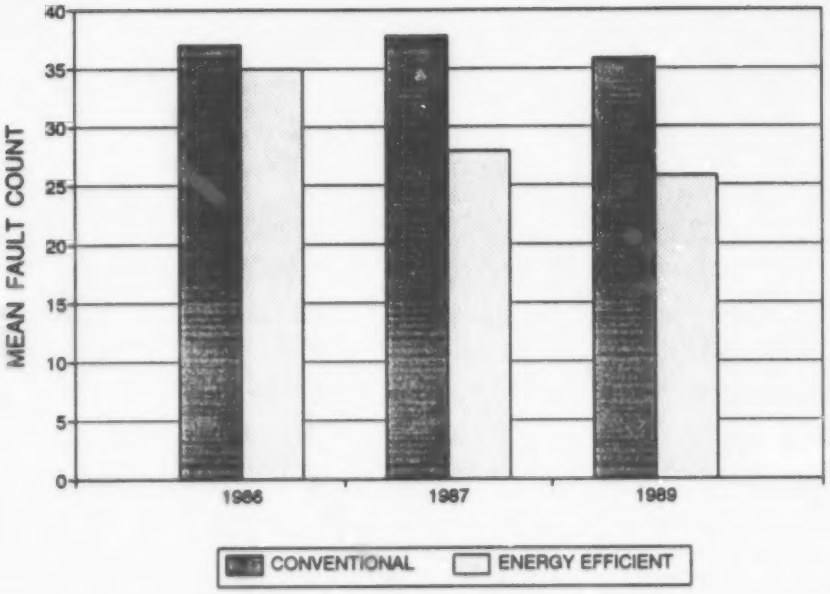
FIGURE 36

ALL VISIBLE STATIONS

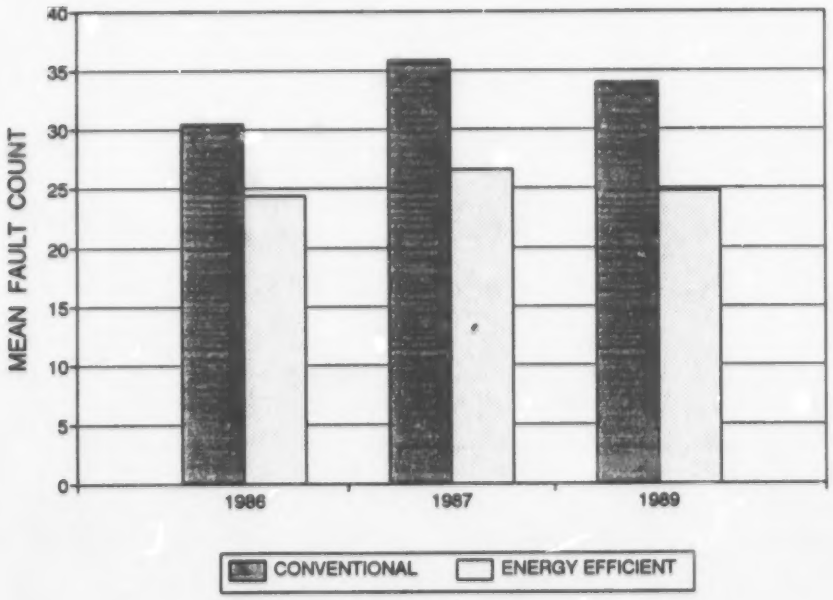
FIGURE 37

CONTINUOUSLY VISIBLE STATIONS

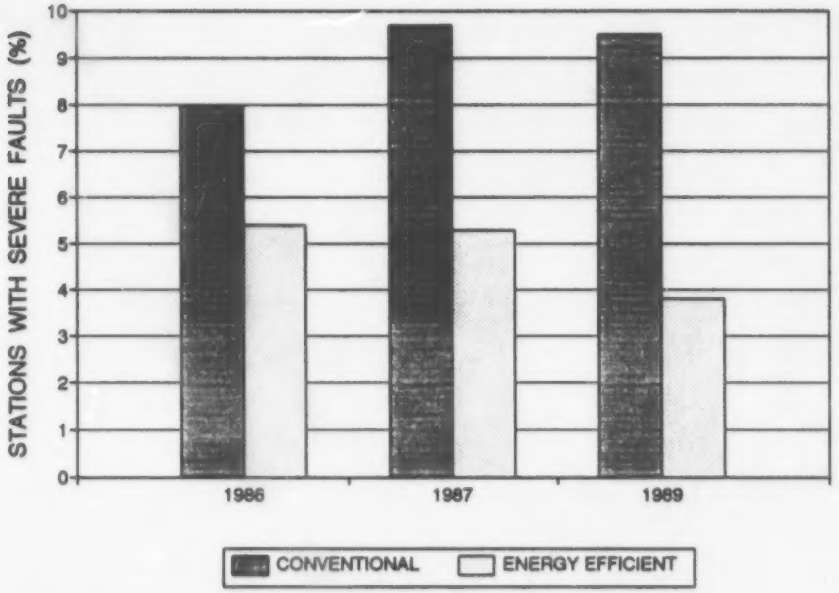
FIGURE 38

ALL VISIBLE STATIONS

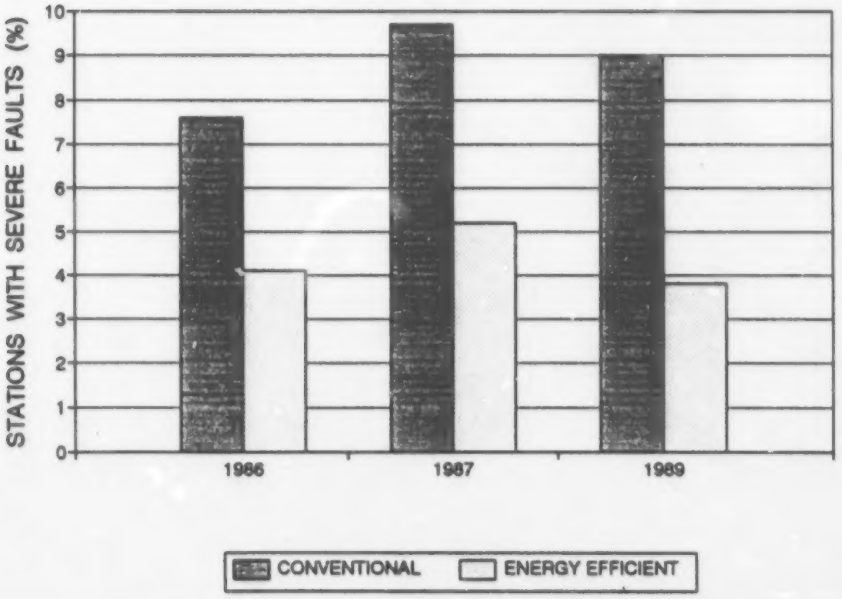
FIGURE 39

CONTINUOUSLY VISIBLE STATIONS

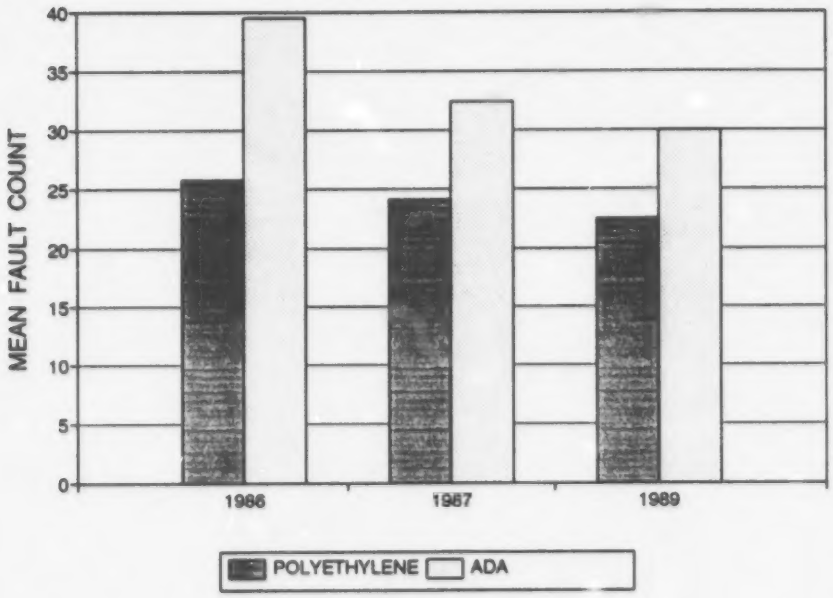
FIGURE 40

ALL VISIBLE STATIONS

Building envelopes constructed using polyethylene air barriers generally performed in a superior fashion to those built using the ADA system, although both functioned in a satisfactory manner. WMC levels were slightly lower in the polyethylene houses, and the mean thermographic fault counts and the percentage of monitoring stations with severe faults were also lower in the polyethylene houses, see Figs. 40 to 43. Both types of construction demonstrated stable airtightness rates.

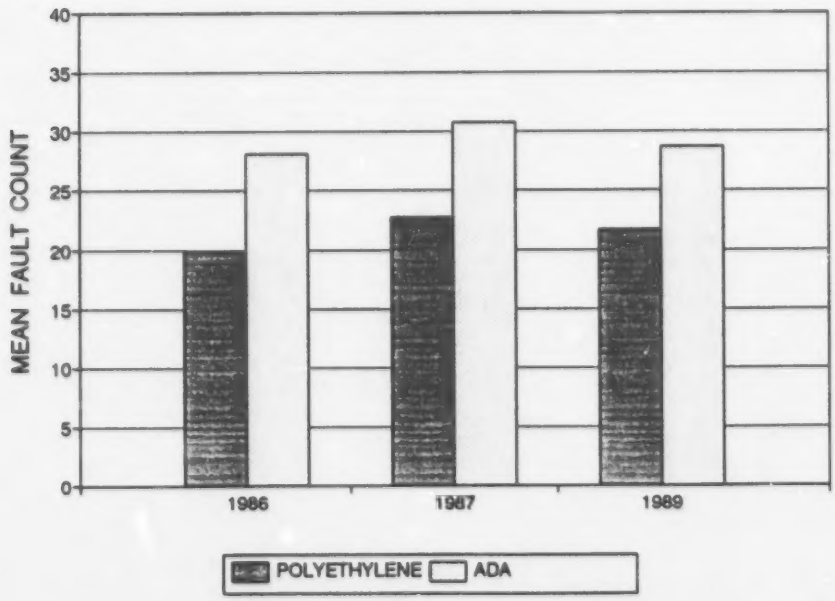
FIGURE 41

CONTINUOUSLY VISIBLE STATIONS

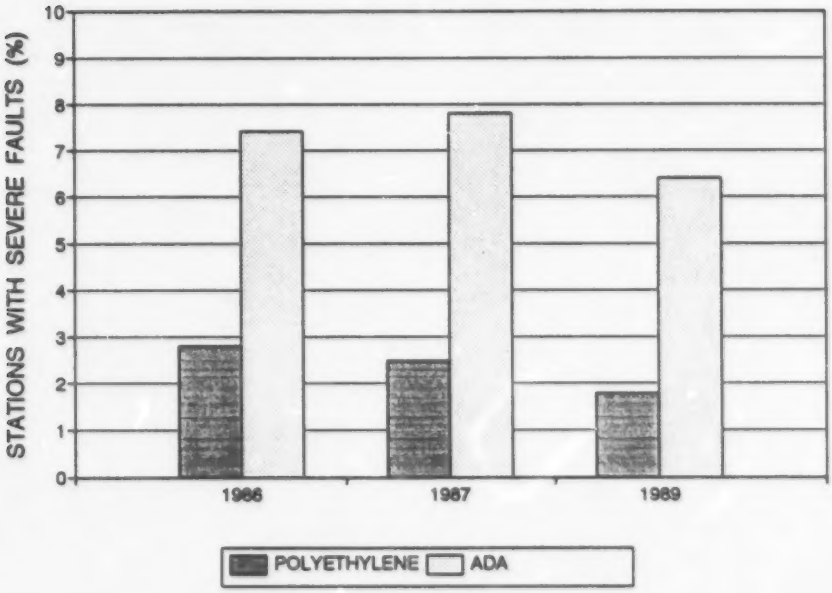
FIGURE 42

ALL VISIBLE STATIONS

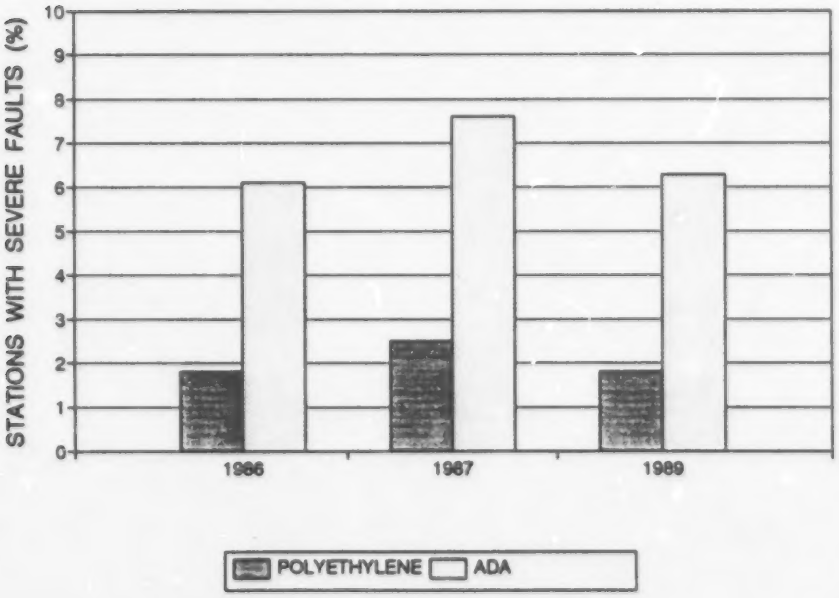
FIGURE 43

CONTINUOUSLY VISIBLE STATIONS

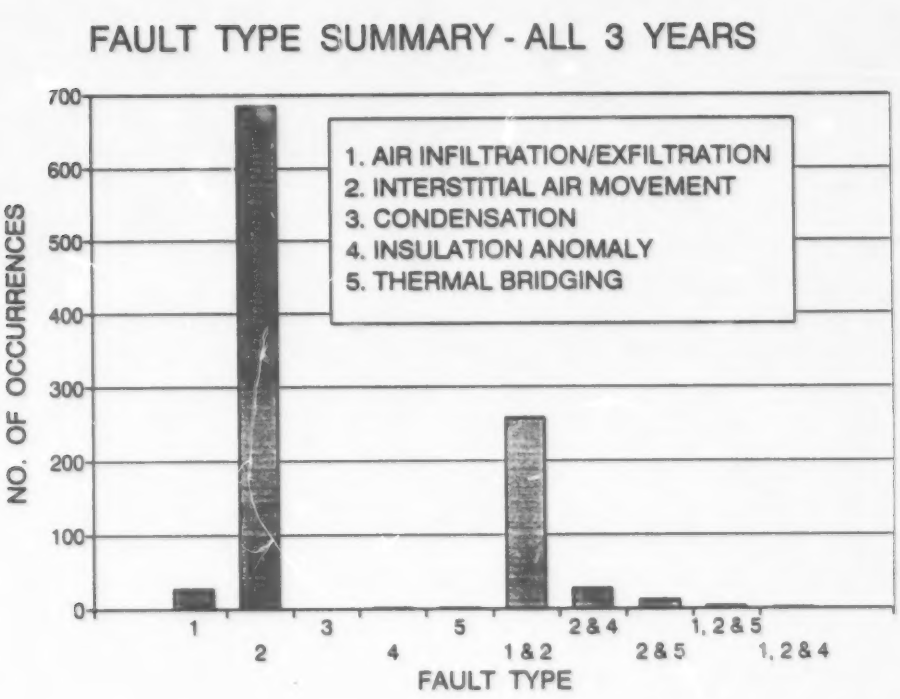
FIGURE 44

Table 26 and Fig. 44 summarize the types of thermographic faults found over the three year monitoring period.

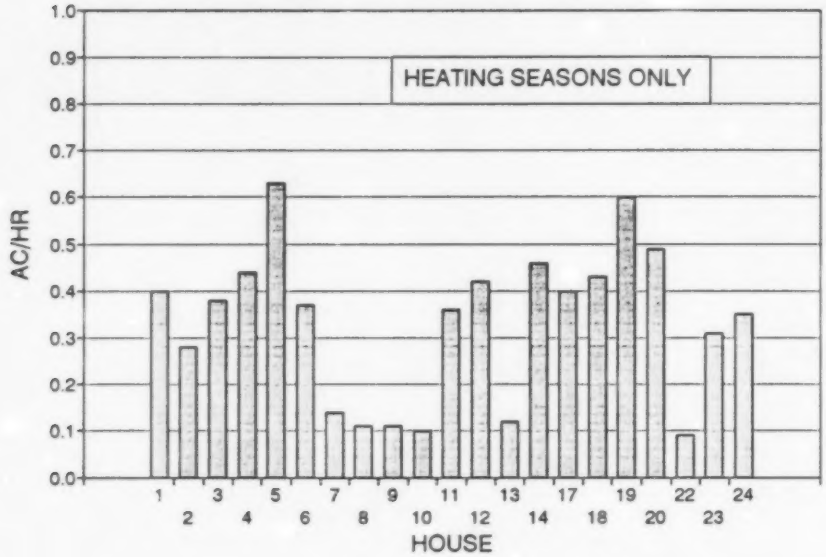
FIGURE 45

Several types of ventilation systems were used in the study houses including Heat Recovery Ventilators (HRVs), integrated systems, central exhaust and point exhaust systems. Mechanical ventilation rates were estimated by monitoring the utilization of the mechanical ventilation systems, in each mode of operation (e.g. high and low speeds and defrost), and combining this data with air flow rates measured during the monthly site visits. The mechanical ventilation rates were then combined with estimates of the natural air change rate calculated using Shaw's method (1981) to arrive at predicted total air change rates. This data is included in Table 6 and shown in Fig. 45.

MEAN AIR CHANGE RATE

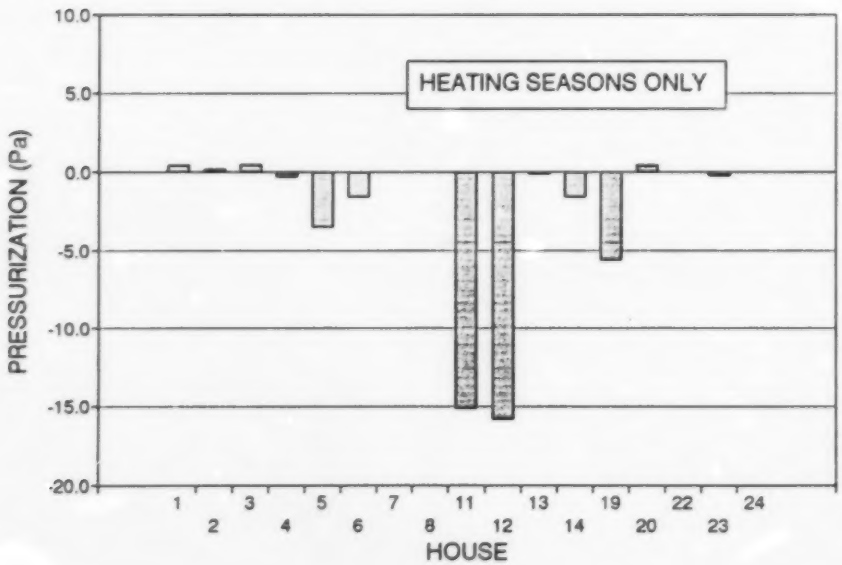
FIGURE 46

Values for C and n for each house were obtained from the most recent airtightness test performed on the structure. The net unbalanced mechanical ventilation rate included the effects of supply air, exhaust air, defrost mode operation, central exhaust fan operation and make-up duct flow. Estimates of the envelope pressurization are included in Table 6 and summarized in Fig. 46.

MECHANICAL PRESSURIZATION
